Central Laboratories Report No. 07-527906.62

**Assessment of Roadmarking
Material at Moonshine and
Hayward's test sites for
Damar Industries Ltd**

**S M Potter
June 2007**

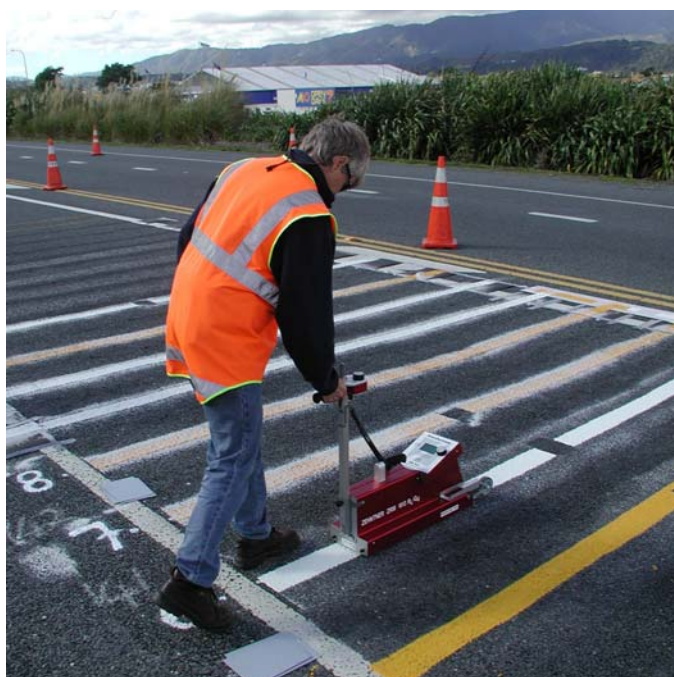
Measuring with the Zehntner instrument immediately after installation.

Measurements were made with this instrument in both the wet and dry condition. For the wet measurements the marking was flooded with water and then measured 60 seconds after the application of water.
